# Unexpected— Earthquake 2011

Lessons to Be Learned

*Edited by  
A. Elena Charola,  
Corine Wegener,  
and Robert J. Koestler*

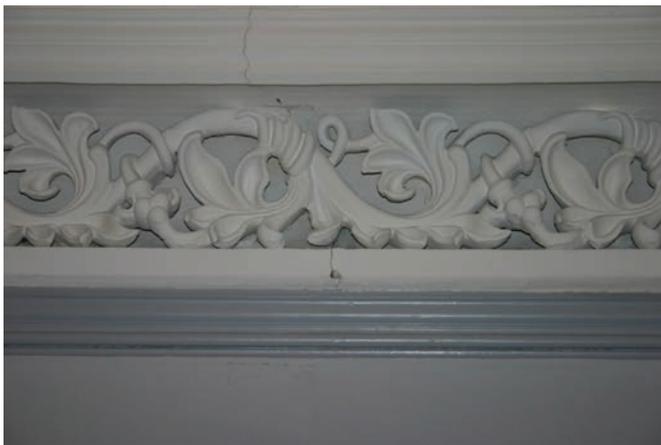
Not only was there damage to the chimneys and towers (Figure 13) but also to walls as evidenced by cracks in the interior of the building (Figure 14).

**FIGURE 14.** The Regent's Conference Room (above) developed a crack (detail, left) that runs through the beam over the bow window. (Smithsonian Institution staff photos.)

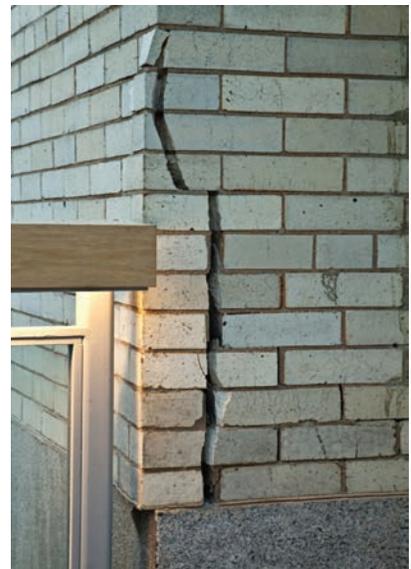
These additions are part of the problem that affected the building during the earthquake. The Main Building had not been designed to have additions attached to it. When the additions were made, each one used different structural systems and building standards, including seismological ones. Thus damage was induced as exemplified in Figure 16.

FIGURE 16. Damage to an original 1911 structural beam, basement of Main Building (left) and face brick separated where East Court building connects with Main Building at a bridge walkway (right). (Smithsonian Institution photos by James DiLoreto.)

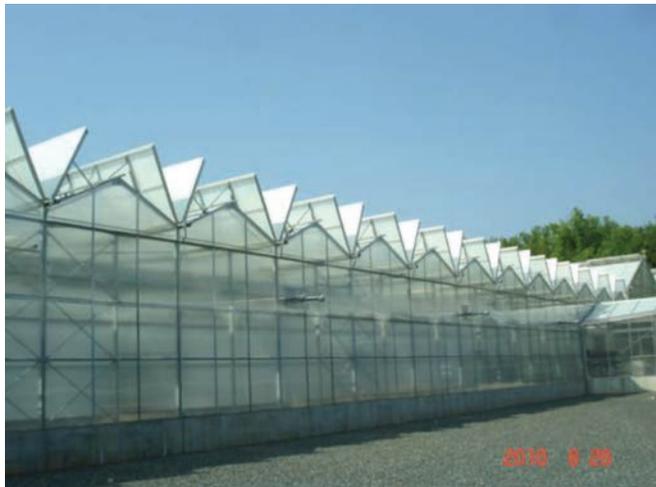
formed of steel framing and glass walls and roofs, did not suffer any damage because they were designed to the new codes and were built in a compact configuration (Figure 23).

FIGURE 23. The Smithsonian Gardens greenhouses suffered no damage. (Smithsonian Institution staff photo.)

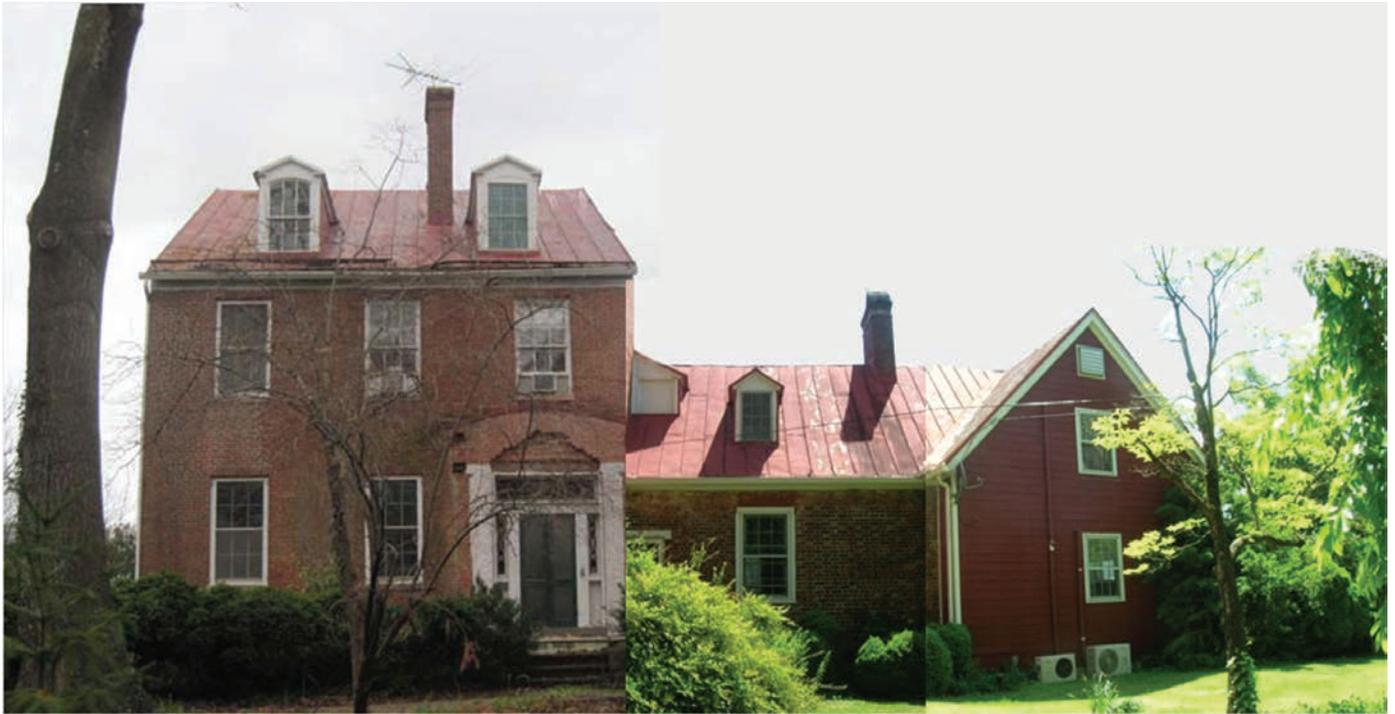
FIGURE 2. Photo montage of the west elevation. Left to right, the larger section of the structure is from 1841, the midsection is circa 1735, and the wooden frame section is from 1979. Note that the porch over the front doorway on the 1841 section has been removed as a result of earthquake damage. (Photos and montage by Sharon Park, Smithsonian Institution.)

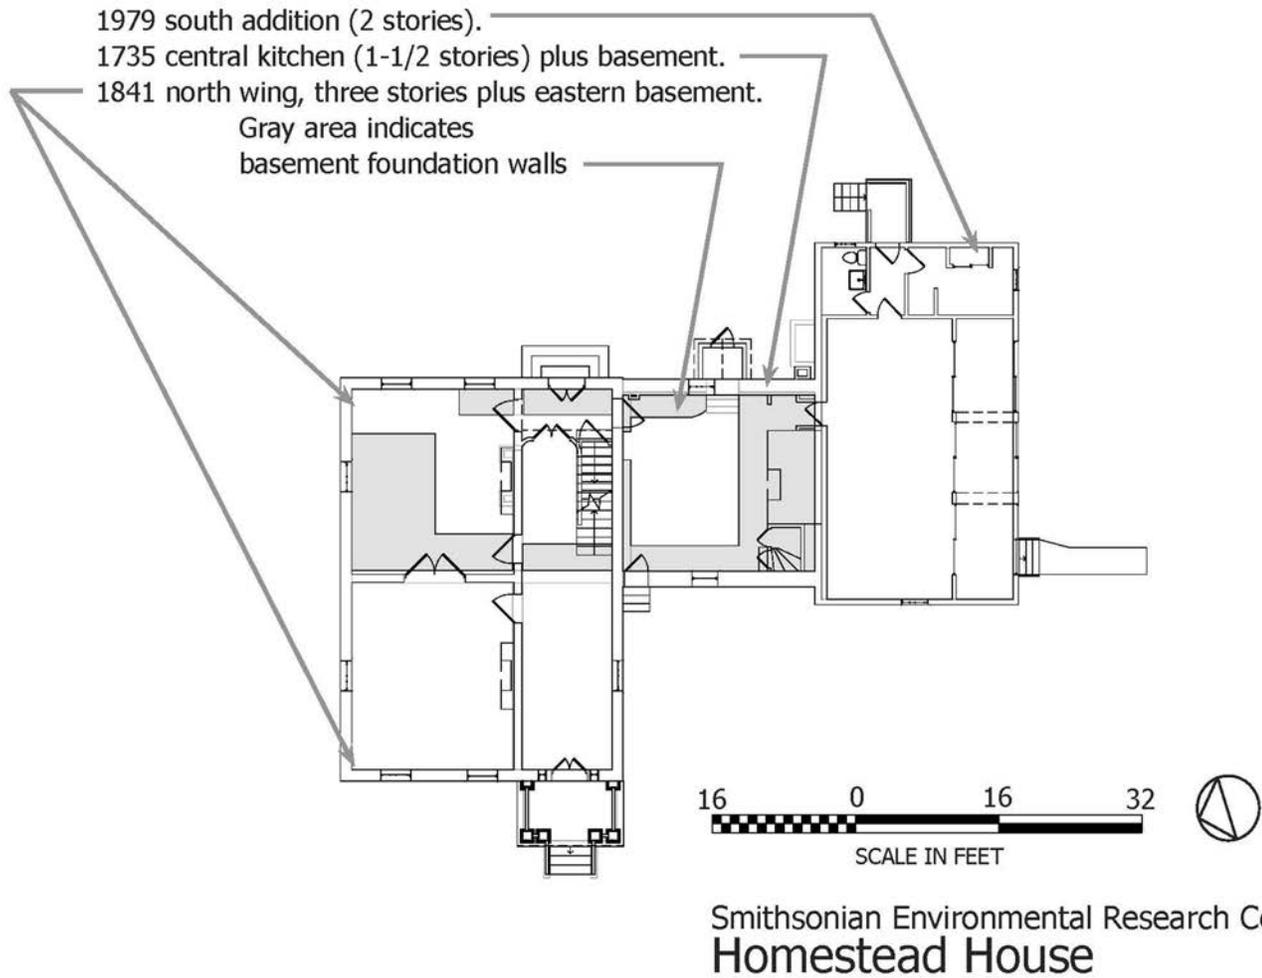
FIGURE 3. The plan of the first floor is superimposed on the existing basement foundation, shown with shading. The 1841 section sits only partially on the early foundations, which was of concern regarding its structural loading capacity. (Drawing by GWWO, Inc./Architects.)

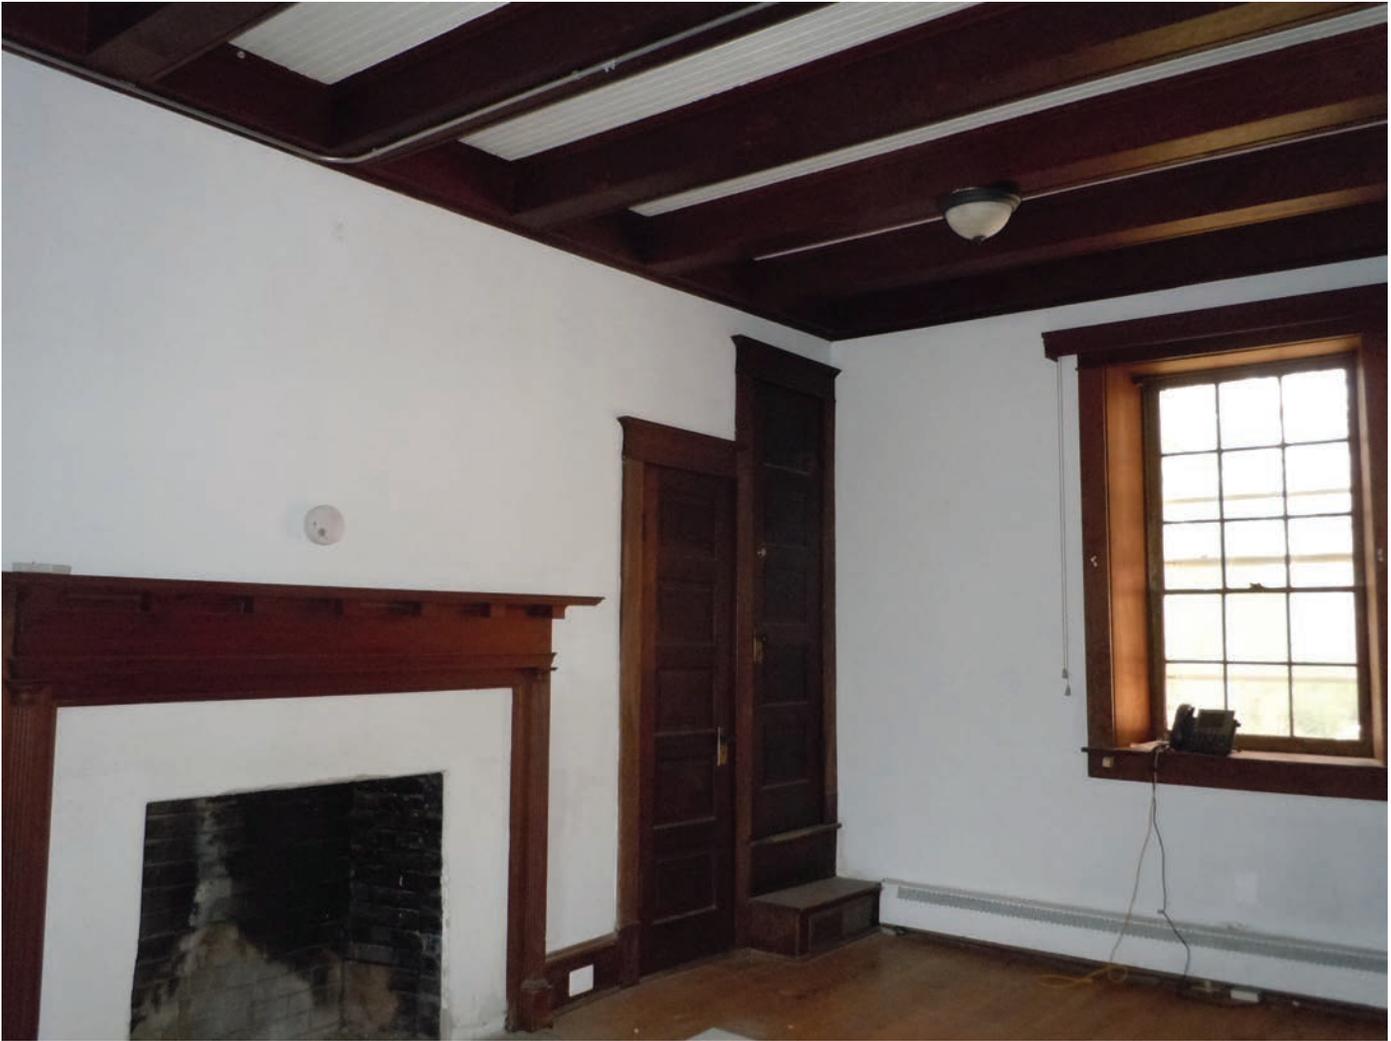
along with its being nestled between two larger masses, resulted in only minor damage, that is, several dislodged chimney bricks, an easily repairable situation.

**FIGURE 6.** The oldest section has served as a modern kitchen for many years. It received dark trim and a wider mantel in the nineteenth century. The door, corner, leads to the upper level via a small curved stair. This portion of the house did not receive much damage as it was protected by the structures on either side. (Photo by Raymond Jones, Smithsonian Institution.)

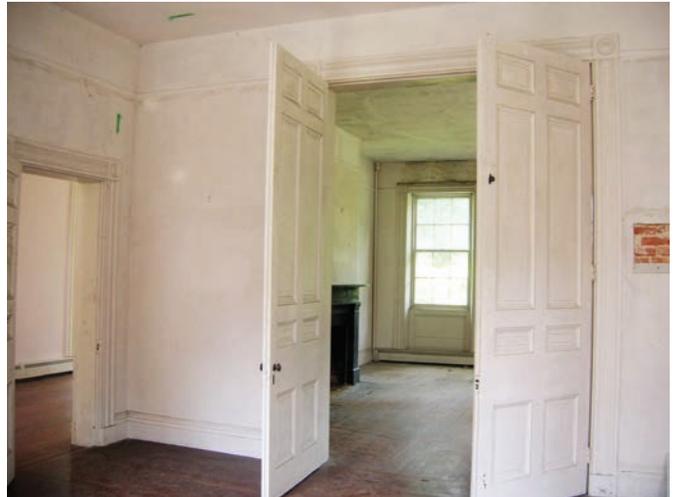
FIGURE 8. The interior after the earthquake. On the left is the handsome side hall staircase. On the right (above) is the wall between the two parlors showing the Greek Revival details of paneled doors, corner blocks in the door frames, and one of the black marble surrounded fireplaces. This wall was of concern as to its possible weakness in shear capacity structurally, but it had no visible cracks. (Photos: left, Raymond Jones, Smithsonian Institution; right, Sharon Park, Smithsonian Institution.)

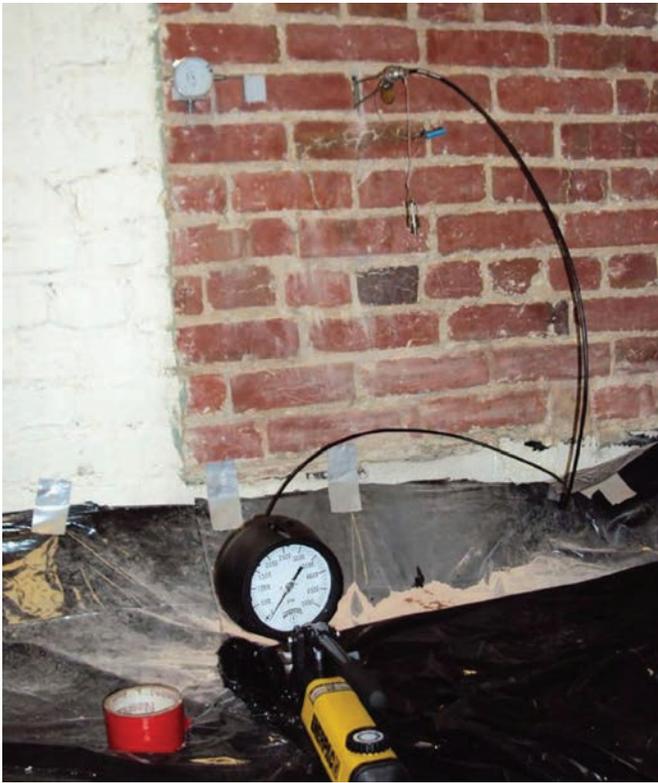
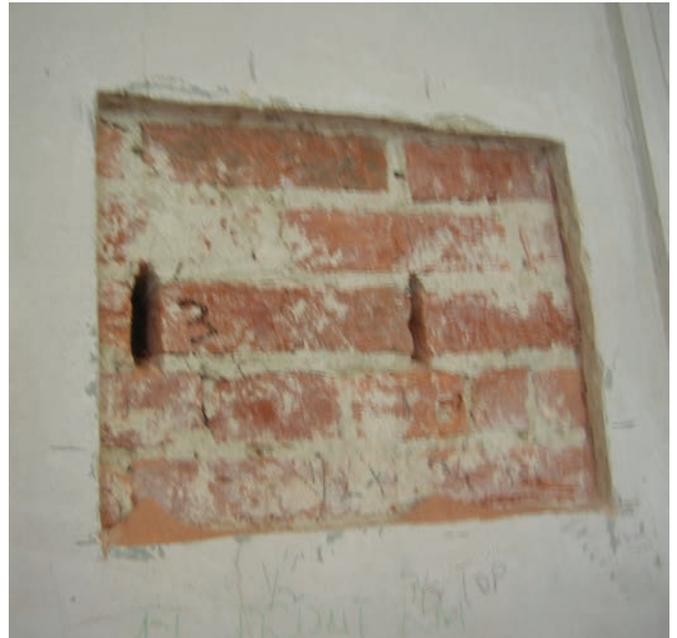
in (20 cm) thick interior masonry wall to see if the added interior shear wall would be necessary. The test followed method C as outlined by the American Society for Testing Materials standard (ASTM, 2009). It is a resistance test that uses a pressure pump and a flat jack plate inserted into narrow slots cut into the mortar joints on each side of selected bricks (Figure 12). The flat jack exerts increasing pressure on the side of the selected bricks until horizontal movement of the brick is observed. The actual shear stress in the horizontal joints is calculated and, based on established ASTM formulas and applying conservative safety factors, the allowable shear stress limit is determined. The results of the in situ testing concluded that the shear stress limit for the wall is 32 psi, not 10 psi as previously expected. Therefore the proposed new shear wall was eliminated from the scope of work.

**FIGURE 12.** The shear stress wall test (left) is a fairly nondestructive test. The several slots made in the walls to place the flat plate jacks (right) are easily repointed after the test. This pressure test proved that the wall, which had shown no visible cracking after the earthquake, was not in need of reinforcement, which would have been an extensive, invasive, and expensive undertaking. (Photos: left, FMC & Associates; right, Sharon Park, Smithsonian Institution.)

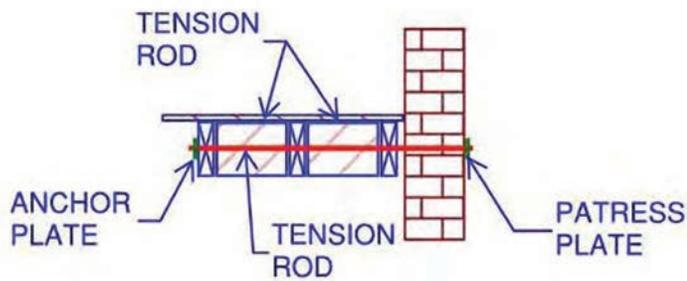
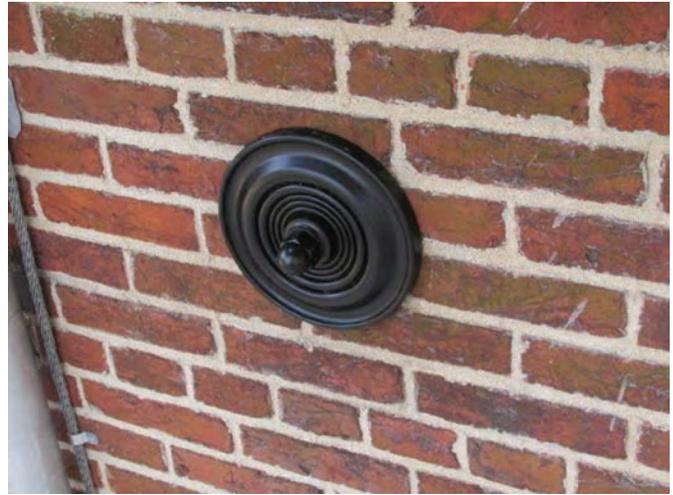
FIGURE 13. In order to tie the floor framing to the exterior walls, the 3 × 10 in (~8 × 26 cm) joists closest to the affected exterior walls were drilled from below to thread new 4 ft (~1 m) long tension rods every 4 ft or so to be anchored by a bolt on one end and a decorative disc plate on the exterior (left). The stainless steel disc has a black baked on finish (right). (Diagram, left: Thornton Tomasetti, Structural Engineers; photo, right: Sharon Park, Smithsonian Institution.)

are stainless steel to ensure a long life and avoid future corrosion (Figure 13).

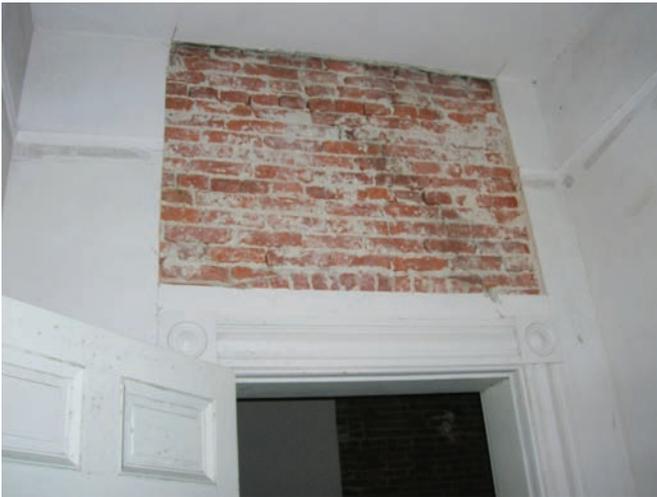
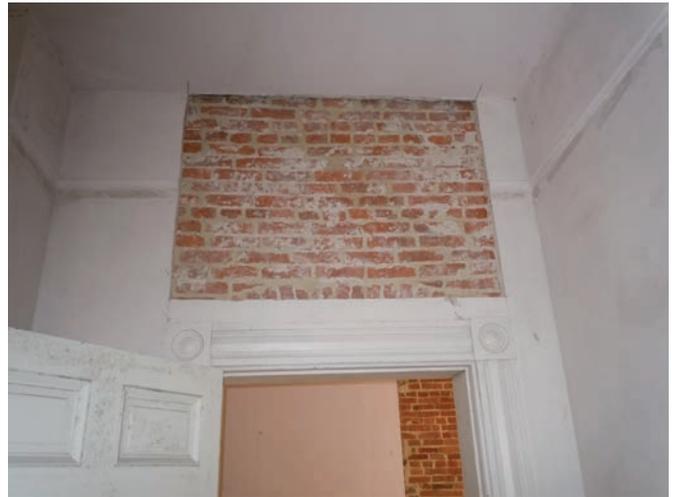
FIGURE 14. Images, once plaster was removed, show the diagonal cracks over a doorway before (left) and after (right) repointing. As with other interior repairs, the plaster will be replaced at a later date. (Smithsonian Institution staff photos.)

walls (Figure 14). In less sensitive areas, such as the basement, the structural repairs could be more visually obvious; in this case all the historic timbers were saved even though many were strengthened with visible new adjacent framing members.

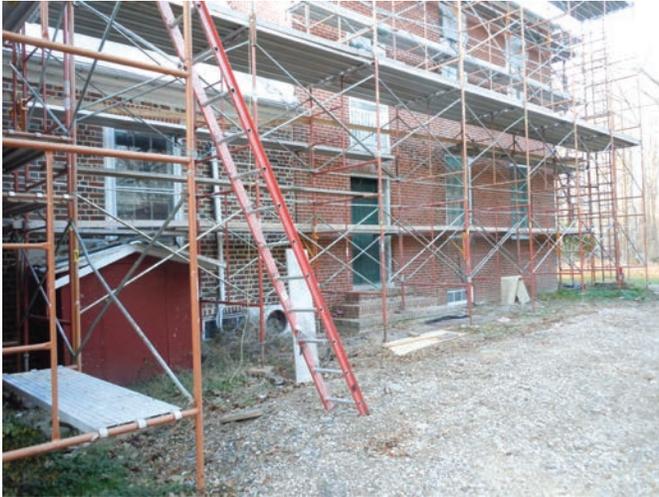
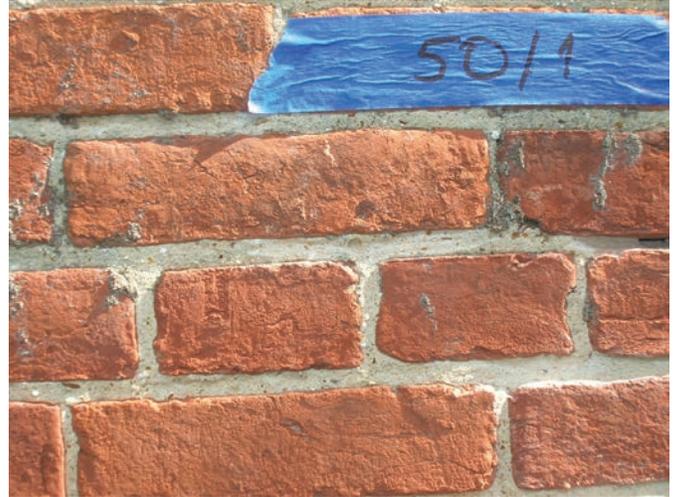
**FIGURE 15.** The image on the left shows the two eras of brick and mortar work. Mock-ups were developed to test for specific composition and appearance to match each era. On the right is seen a sample for the 1841 section with the bottom two courses of new lime-rich mortar with shell aggregate to match the upper course by the blue tape. The 1735 section had a slightly different aggregate mix and a tooled joint detail. (Photos: left, Raymond Jones, Smithsonian Institution; right, Bryan Fisher, GWWO, Inc./Architects.)

repointed in the twentieth century with very hard Portland cement-based mortar, which was causing additional spalling decay of the bricks. So the repointing of the exterior walls to strengthen them would also be corrective and extend the future of the brickwork by using an appropriate softer, pliable lime-based mortar. For the most part, the old mortar was removed by hand (no grinders or power tools to avoid damaging the brick joints) and replaced by masons experienced in working with lime mortars on historic buildings. The brick surfaces were washed using a garden hose, natural bristle brushes, and water (no power washing or chemicals) to remove surface dirt prior to repointing and to prepare the brick for the lime mortar.

match their unique historic appearance. Missing bricks at the chimney, entrance porch, and window heads used bricks reclaimed after the earthquake or from nearby salvage supplies. Several of the cracked or aged stone window sills were repaired or replaced with matching stone sills to ensure a complete exterior refurbishment (Figure 15).

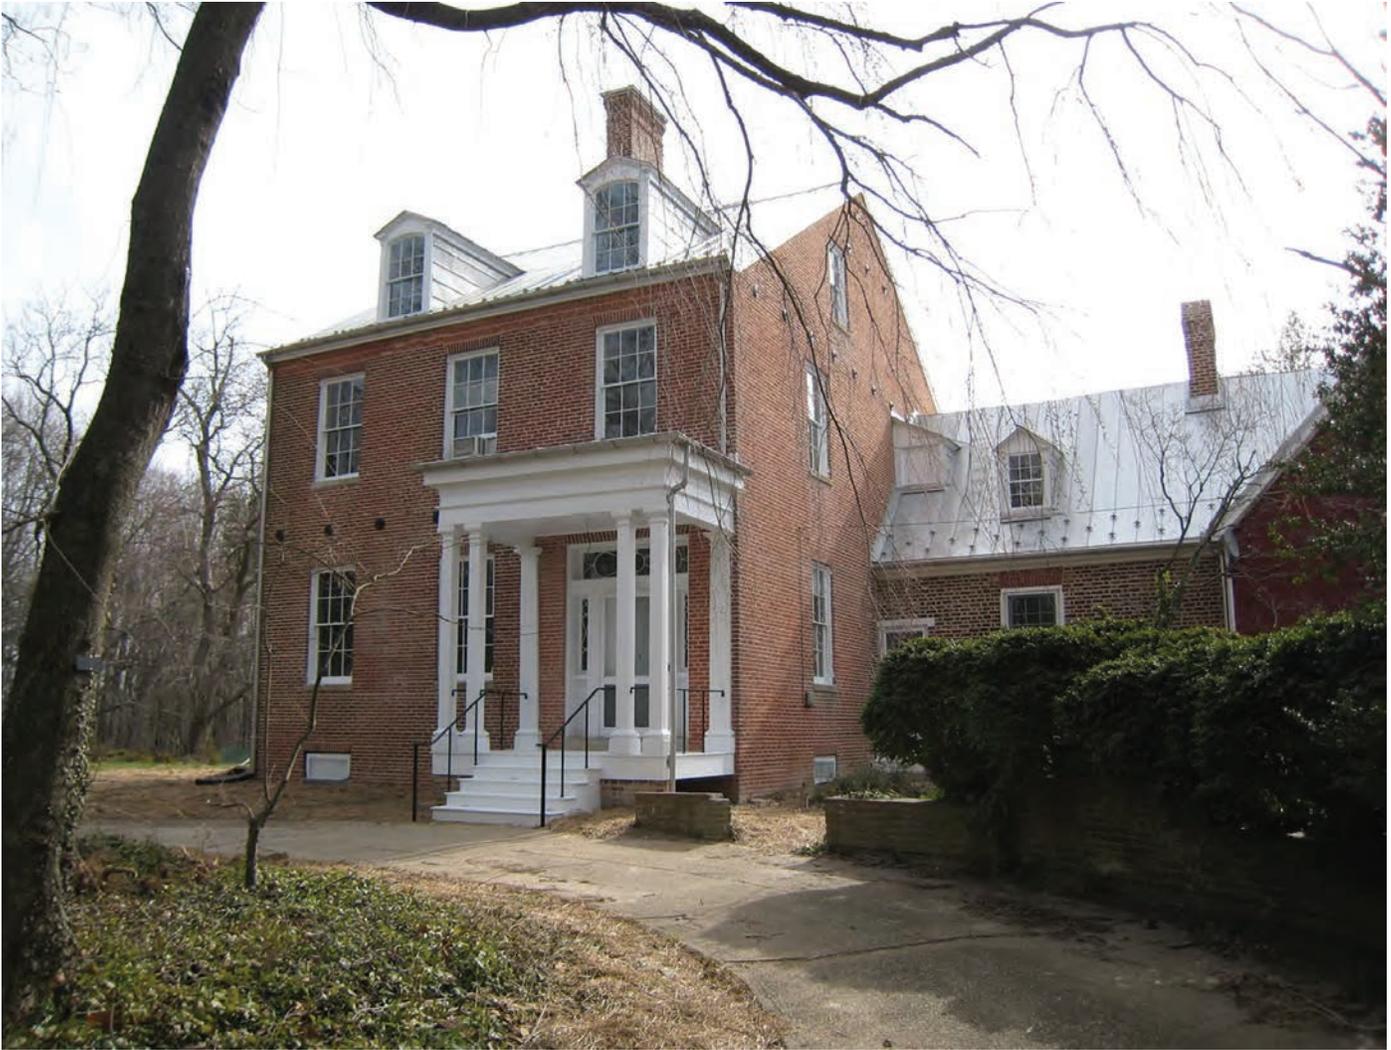
FIGURE 16. The Homestead House after completion of the intervention in spring 2013. (Photo by Sharon Park, Smithsonian Institution.)

The roof was already scheduled for replacement. The old metal roofing and sheathing was stripped off, additional ventilation was discreetly added to the gable ends to extend the roof's life, and the roof rafters were strapped to the second-floor ceiling joists to complete the structural tie downs recommended by the engineers. The new roof is of a similar standing seam configuration as before the earthquake. Figure 16 shows a view of the house after completion of the intervention in spring of 2013.

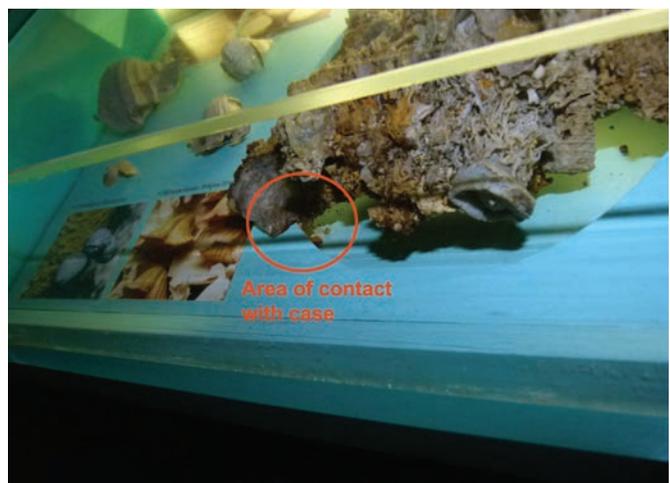
The majority of the damage to the invertebrate fossil specimens in the Paleontology Halls happened to the silicified specimens. Silicified fossils that have been etched out of limestone blocks, such as Permian bryozoans, brachiopods, and mollusks, are by their nature extremely fragile and vulnerable to breakage at the slightest touch. The original calcite and aragonite that comprised their structures has been dissolved out and incompletely replaced with silica over the millennia. When the specimens are acid etched out of the limestone what remains is a very light, airy, and brittle cast of the original. As these exhibits were vibrated and bounced in their brackets, they were abraded and pieces broke off and fell to the floor of the case (Figure 7).

FIGURE 7. A group of silicified fossils that were acid etched out of limestone bounced out of their cradle and abraded against the display case. (Photo by Steve Jabo, Smithsonian Institution.)

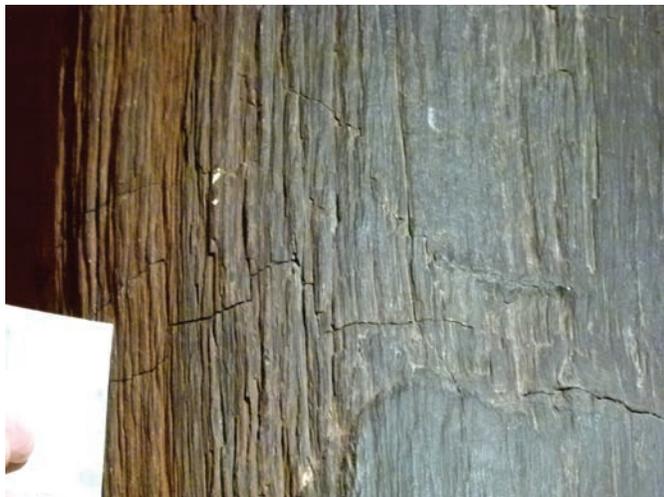
The only real damage to the paleobotanical specimens appears to have been when two trunks of *Araucarioxylon*, a Triassic conifer, were each cracked through while standing upright in the exhibit (Figures 8, 9). These fossils were formed when the original plant cells were replaced

FIGURE 8. A trunk of a 240-million-year-old fossil *Araucarioxylon* tree with a crack through it. (Photo by Steve Jabo, Smithsonian Institution.)

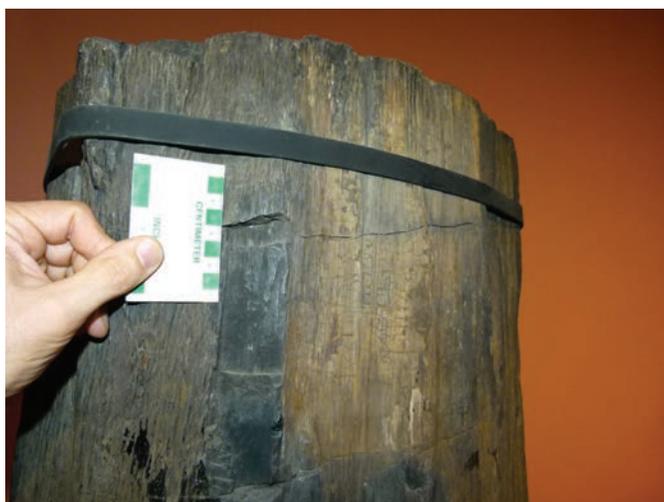
FIGURE 9. Another trunk of a 240-million-year-old fossil *Araucarioxylon* tree with a crack through it. (Photo by Steve Jabo, Smithsonian Institution.)

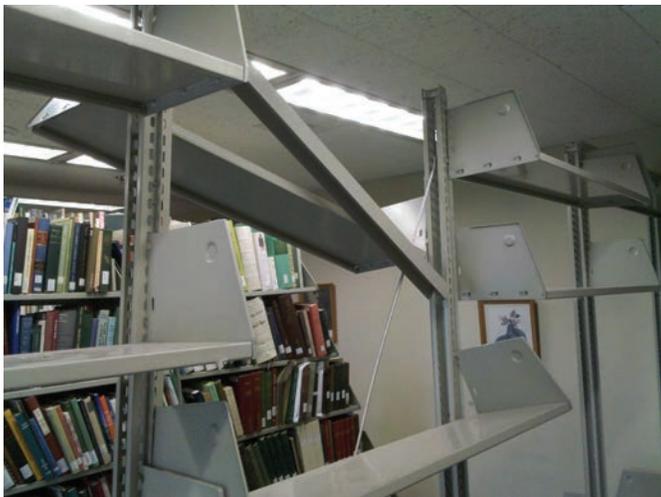
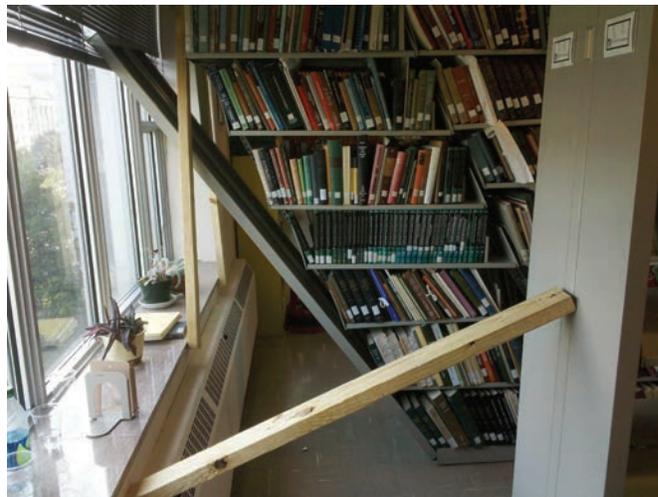
Of the two other libraries in the NMNH, the Anthropology Library located on the third floor of the Main Building suffered the more noticeable effects from the shock. The shelf bracing detached from the walls, but the 3.4 m (11 ft) shelving remained upright in spite of the earthquake. When the assessment was done, few items were found on the floor. While waiting for building management staff to reattach the bracing bolts to the walls, staff carefully returned books to their rightful places and roped off the affected areas with caution tape. However, during the interim period, the library staff pulled requested books from the cordoned off areas, hoping that there would not be any new aftershocks.

FIGURE 1. Left, twisted and broken shelving. Right, stacks shifted and distorted, leaning perilously against glass windows overlooking Constitution Avenue. (Smithsonian Institution photos by M. Kalfatovic; see more at <http://www.flickr.com/photos/travelinglibrarian/sets/72157627394103839/with/6077290443/>.)

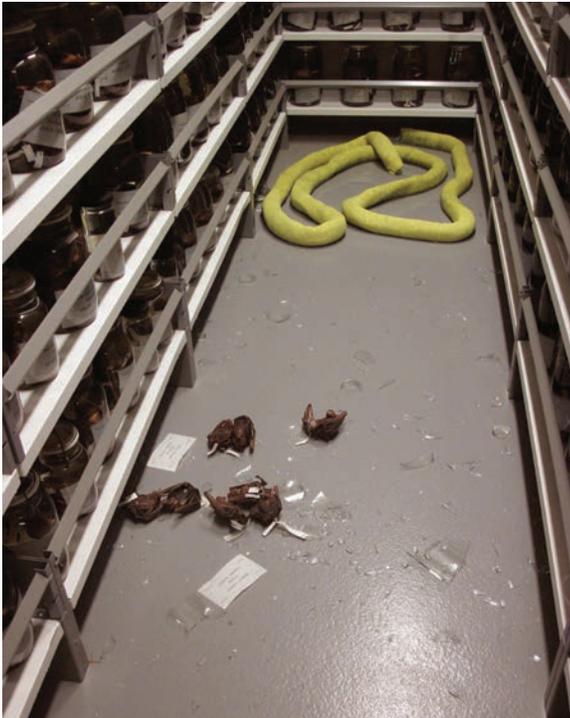
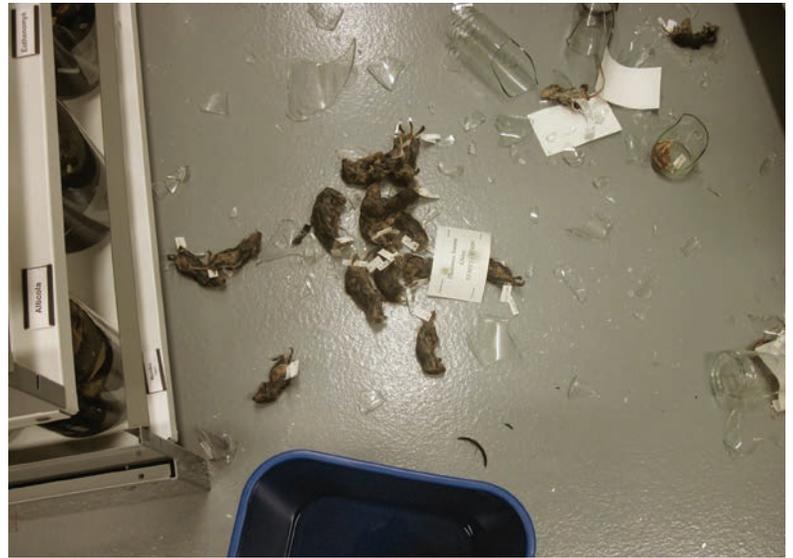
**FIGURE 2.** Absorbent snakes (left) soak up pools of alcohol, and (above) specimens along with paper jar labels from each aisle are gathered into buckets. (Photos by Suzanne C. Peurach, USGS Patuxent Wildlife Research Center.)

all solid debris into specially marked, rolling hazardous material cans. After the rooms were cleared of specimens and broken glass, we rolled the hazmat cans out of the building and into the open air of the parking lot for disposal by building management staff.

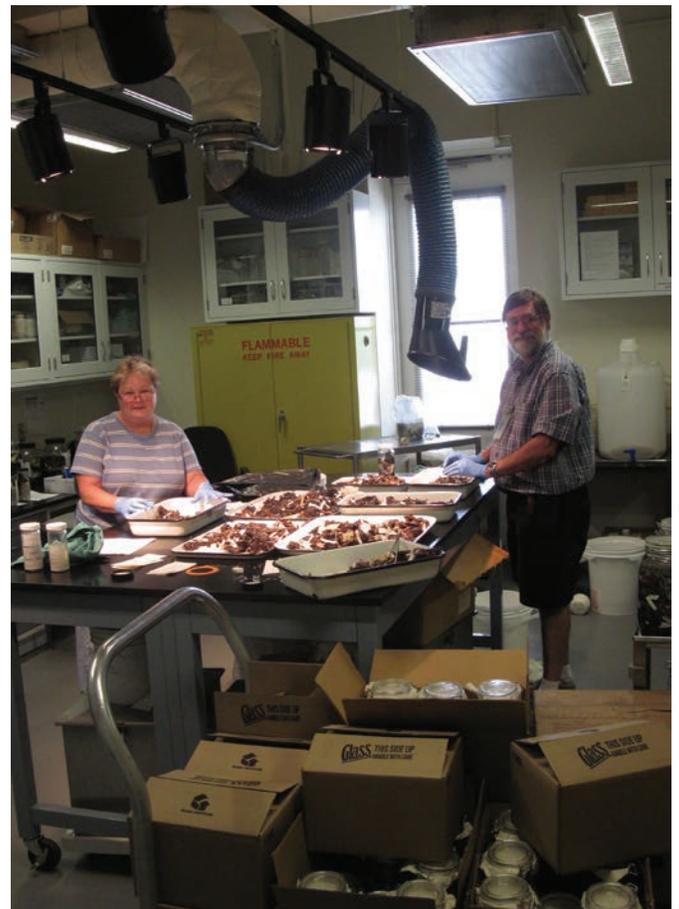
During the following weeks, the DOM staff worked to sort and organize specimens so that they could be re-jarred and reinstalled into the collection (Figure 3). An estimated 50 jars containing about 2,000 specimens were broken during the earthquake. Because every individual specimen in the collection is uniquely labeled by its catalog number and data captured, and shelf arrangement is based on scientific name, country and state, and catalog number sequence, it was fairly simple to generate print-outs to organize the sorting process. In the end no specimens had suffered long-term damage, and data loss was limited to two individuals that had been disassociated from their labels.

**FIGURE 3.** (Right) Linda Gordon and Craig Ludwig work to sort specimens recovered from broken jars damaged by the 2011 earthquake. (Photos by Suzanne C. Peurach, USGS Patuxent Wildlife Research Center.)

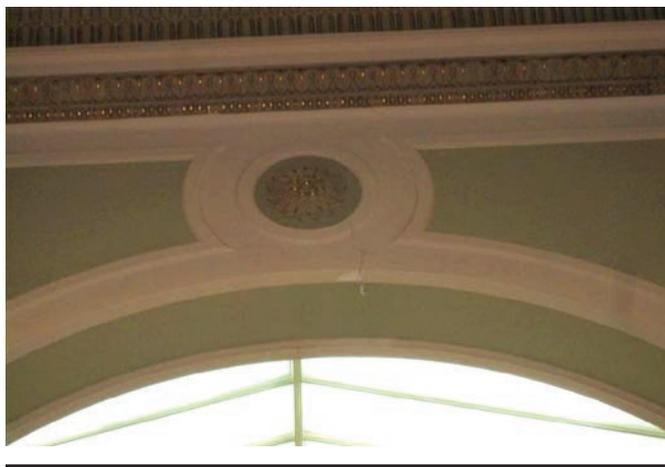
**FIGURE 1.** One of several cracks in the arches around the Great Hall (above) and its pilasters (right). (Smithsonian Institution photos by Office of Facilities, Management and Reliability staff.)

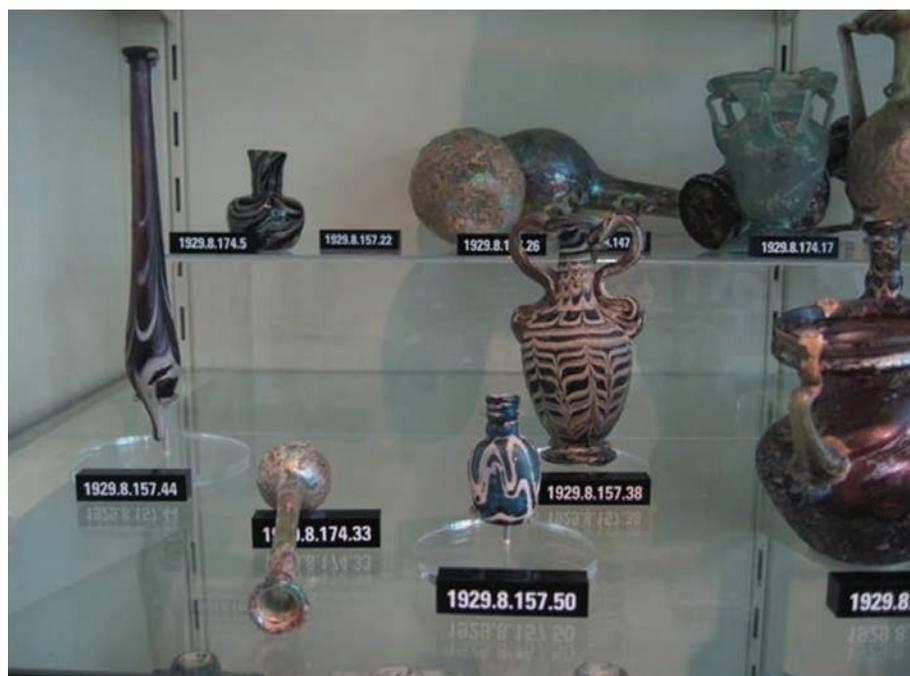
The American Art Museum collections suffered no catastrophic damage as a result of the earthquake. A number of items in the display cases of the Luce Foundation Center at the museum shifted position or fell over (Figure 1), such as the Roman vases acquired in the 1920s (before the museum's collecting goals were redefined to focus on American art and artists). But only eight works were damaged to a degree that warranted removing them from public view, and none were irreparably damaged.

**FIGURE 1.** Roman glass vases toppled over during the earthquake but suffered no significant damage. (Smithsonian Institution staff photo.)

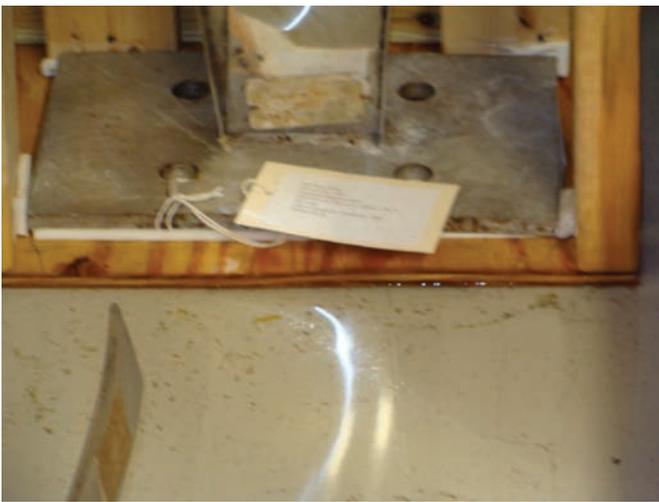
FIGURE 2. Dirty water pooled on the surfaces of floor and in packing crates. (Smithsonian Institution staff photo.)

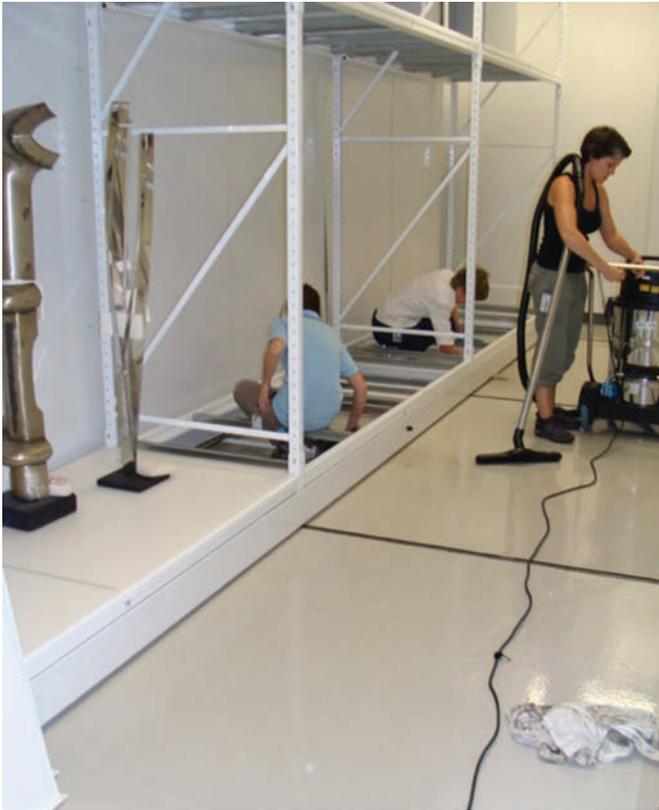
FIGURE 4. Cleanup following the earthquake and flood from the sprinkler system. (Smithsonian Institution staff photo.)

Requests from the HMSG and other units to MSC staff for such supplies surpassed the available stock. Since the earthquake, the cause of the sprinkler head failure has been remedied and the MSC and HMSG have stockpiled additional emergency supplies.

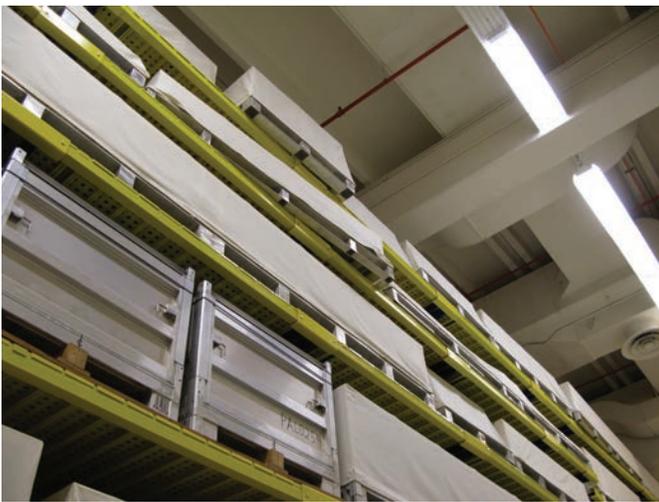
FIGURE 4. Walking of large palletized objects on cantilever shelves, in Pod 4. (Smithsonian Institution photo by David Rosenthal.)

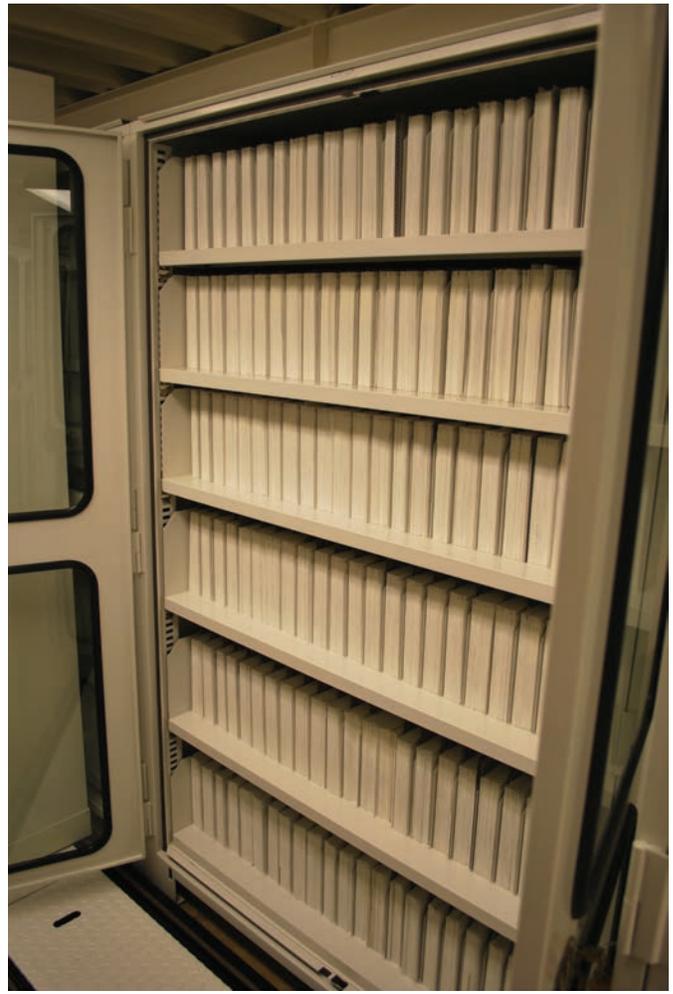
FIGURE 5. National Anthropological Archives glass plate negatives in Pod 2, level one. (Smithsonian Institution photo by David Rosenthal.)

because it contains the collections of our National Anthropological Archives, which includes over 30,000 priceless glass plate photographic negatives created during the last quarter of the nineteenth century. In addition to other things, this collection represents the visual legacy produced by the Smithsonian's Bureau of American Ethnology (1878–1964) and includes thousands of historical images of Native American Indians and their traditional cultures and environments. Thanks to the manner in which these plates are housed—each in an archival Tyvek sleeve and slotted in groups of 8–10 between metal dividers—these treasures were unaffected by the event (Figure 5).

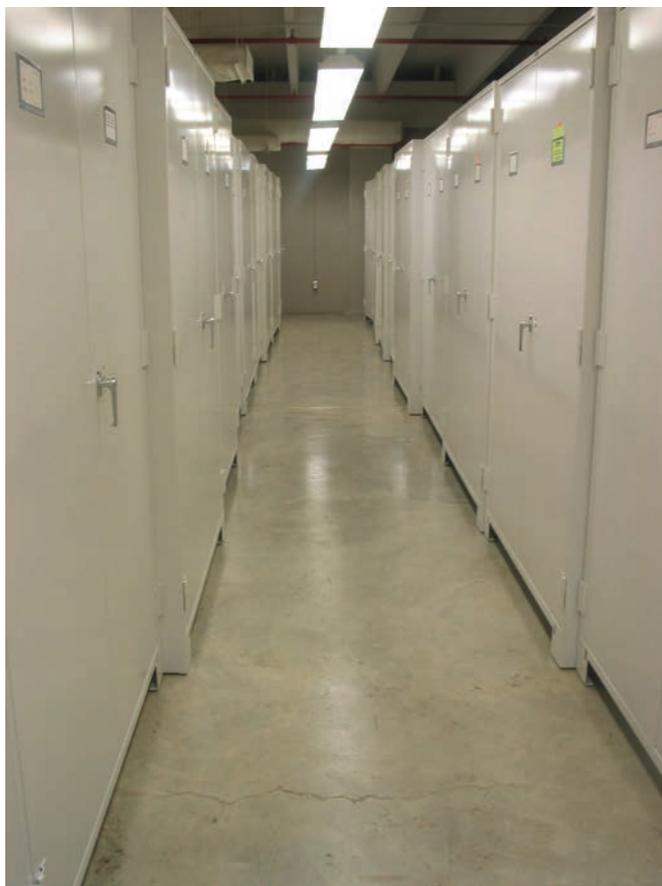
It was principally in Pod 1—particularly on level three of that pod—that we would realize that the seismic event was much more than a “tempest in a teacup.” On this level, where Viking storage cabinets once marched precisely down long aisles in marionette fashion, they were now consistently out of alignment and askew (Figure 6).

**FIGURE 6.** Shelf cabinets out of alignment in Pod 1, level three, following the earthquake. (Smithsonian Institution photo by David Rosenthal.)

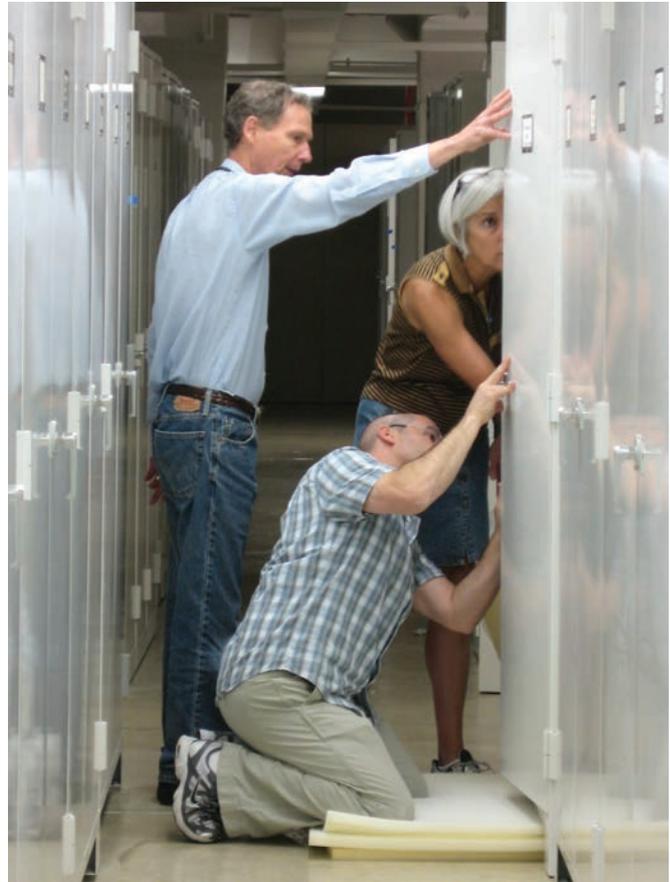
FIGURE 7. With foam in place, staff checking for hanging objects as shelf cabinet is opened. (Smithsonian Institution photo by David Rosenthal.)

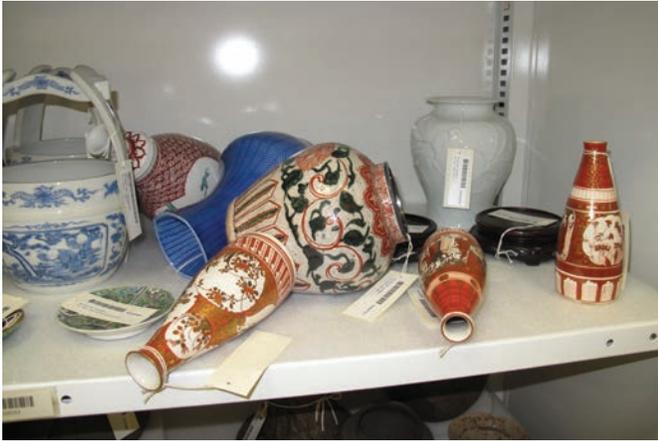
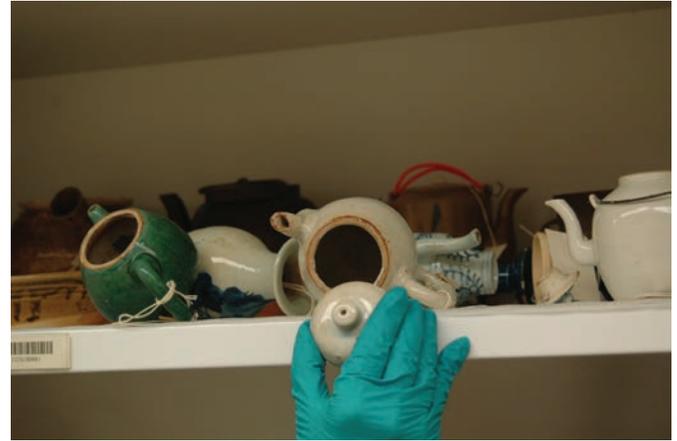
FIGURE 8. Examples of hanging ceramic artifacts. (Smithsonian Institution photos by David Rosenthal.)

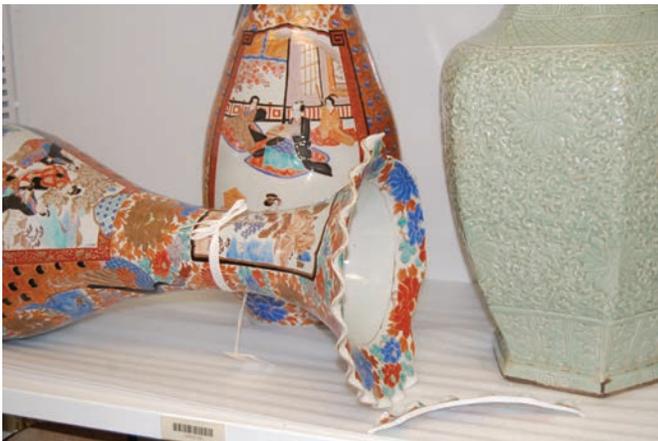
The toppling of these smaller and lighter objects sometimes caused them to roll to the front of the shelf even though each shelf had an Ethafoam liner. We realized the consequences of this the hard way when, upon opening a door, one such small ceramic dropped onto the concrete floor and broke. This happened even though we were very cautious in opening cabinet doors, doing so slowly, to ensure that objects that had moved would not drop. Realizing the possibility that this could happen multiple times, we regrouped and came up with the idea of placing foam pads that were as wide as the cabinets on the floor at the base of each cabinet before we continued to open additional doors (Figure 7). Then, as a door was opened slightly, one team member would attempt to peek into the cabinet to determine if there were any “hanging objects” (Figure 8). If one was sighted, an attempt was made to reach in and secure it or push it back onto the shelf. This further slowed the work of the survey, but it saved an estimated 10–12 artifacts that might have broken on the concrete floor. Even with this care, however, it was at times impossible to keep a small object from dropping to the next level and striking the metal edges of the cabinet, something that damaged at least three other small ceramics vases (Figure 9).

FIGURE 9. Japanese vase that toppled, causing rim breakage. (Smithsonian Institution photo by David Rosenthal.)

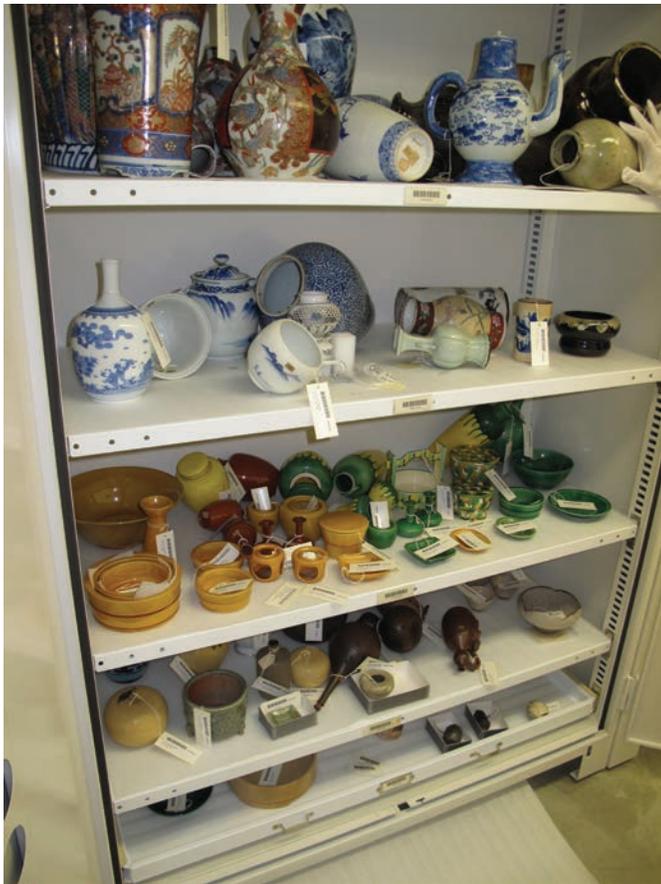
FIGURE 10. Example of crowded Japanese ceramics. (Smithsonian Institution photo by David Rosenthal.)

careful manner in which the Collections Support Staff had aligned and balanced the cabinets at the time our collections moved into the facility. With regard to all of our Asian ceramic collections—which were among the first to have been moved to the MSC back in the late 1980s—we now need not only to restore those objects that were broken but to implement a decompression of the collection. In the process of doing this we anticipate developing stabilizations (e.g., bases and cradles) for specific objects such as tall cylindrical ceramics and other objects that may be top heavy due to their shape or design. Decompression will likely cause us to think further about the relationships among the size, weight, and shape of objects on a given shelf to insure that larger objects do not roll, topple, or impact smaller fragile ones. Small fragile ceramics will need to be appropriately grouped and placed in blue board trays or other housings that will prevent them from rolling and serve to buffer them from the movement of any larger adjacent objects in the event of a future seismic event (Figure 12). Currently there is also consideration for equipping some cabinets—those containing fragile, high-value objects—with glass portals that would allow staff to view the objects housed therein. In the future, this could prevent accidental damage that might be caused by an object falling when a door is opened.
